### **Electric Power Lifelines**

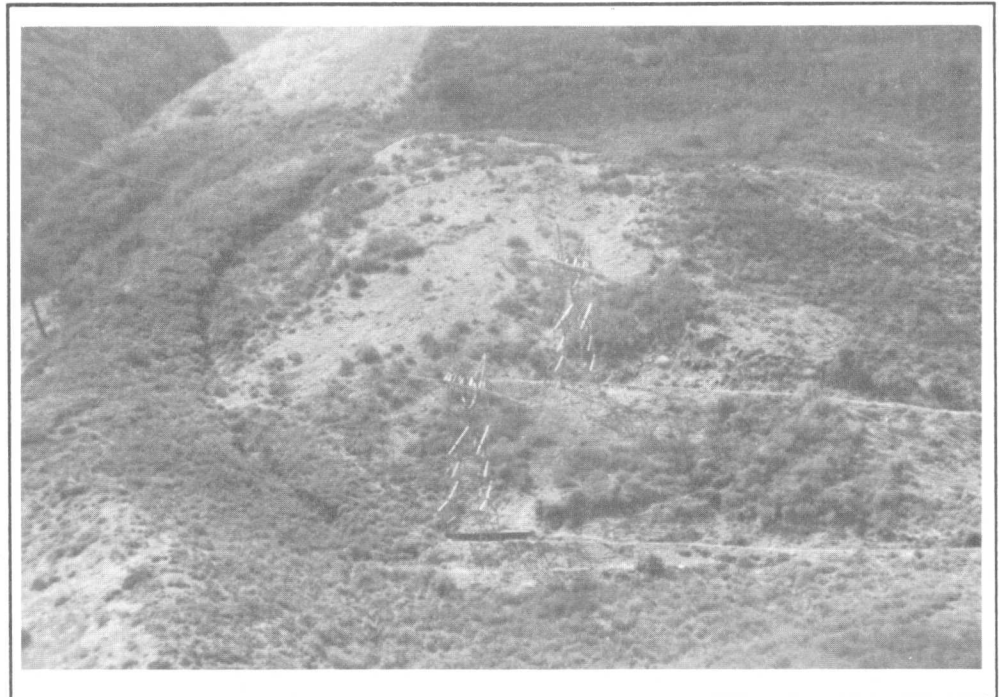
Figure 17 A Landslide Scar With Power Towers In The Slide Area

Transmission lines often traverse more rugged areas, and as such they are susceptible to landslide damage. Figure 17 shows two transmission towers located in an old landslide scar (the original towers were damaged in the landslide). This location is an important collocation site, as a buried natural gas transmission pipeline and the railroad tracts are located just below the slide area. Figure 18 shows the location of two high voltage power transmission tower systems, a buried natural gas transmission pipeline (shown by a surface marker), and the 8- and 14-inch buried petroleum products pipelines (also shown by a surface marker).

This location is in the fault rift zone of the San Andreas fault (in Lone Pine Canyon).

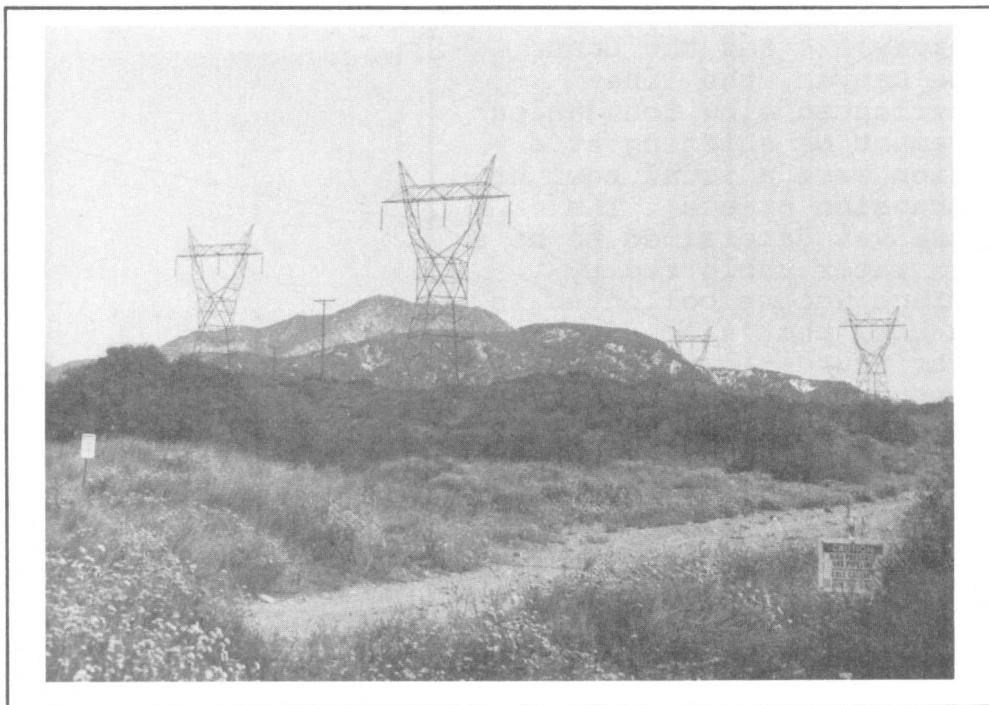
Figure 18 Power Lines, Natural Gas & Petroleum Products Pipelines Intersection Over the San Andreas Fault Rift Zone

the San Andreas fault and rift zone) is the most significant collocation condition for the electric and the fuel lifelines.
